The use of Saturn

A winged implant, for Immediate Loading after Socket Preservation

Author: **Dr. Zvi Laster D.M.D**

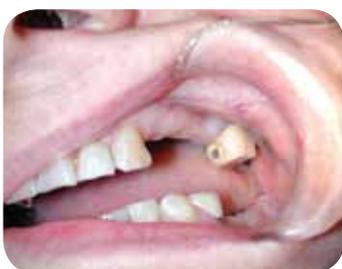
The bridge was cut mesial to #27 while #24 and #25 were extracted. Due to bone loss, the damaged sockets were preserved using allograft freeze-dried bone particles (Fig. 2).

Fig.2 - Socket preservation of #24 and #25.

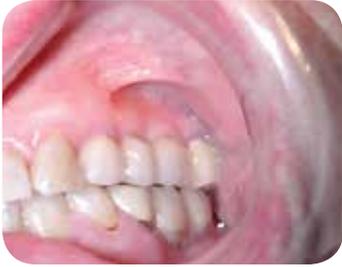
Healing of the site was uneventful with satisfactory results (Fig. 3).

Fig.3 - Complete healing of the extraction site.

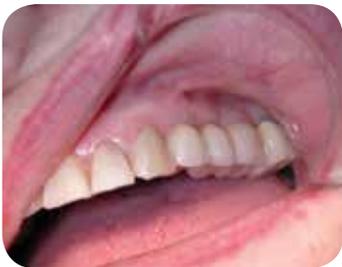
The patient returned for 1 year recall. On examination, a sound pink and healthy attached gingiva was present without any pocket formation around the implants (Fig 13).

Fig.13 - Final restoration 12 months after installing.

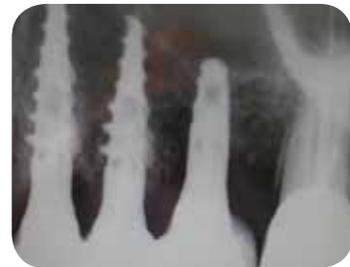
Next recall was 2 years post installment of the final restoration. Examination revealed no change in soft tissue condition. (Fig.14)

Fig.14 - Final restoration 2 years after installment.

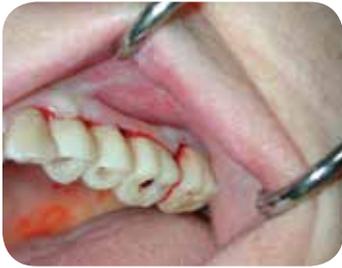
Immediate loading was planned for the second stage, and a preformed temporary bridge that will function also as a drilling guide was constructed (fig.4).

Fig.4 - Temporary Bridge and Guide.

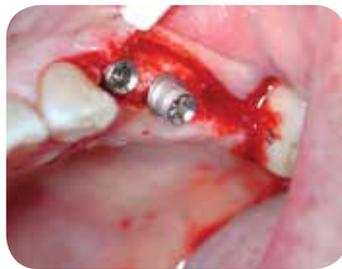
3 months post extraction and socket preservation, the guide was used to mark the drilling points for implantation (Fig.5)

Fig.5 - The temporary bridge is used as a guide for drilling.

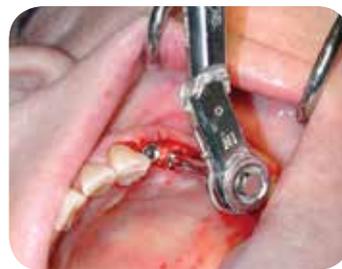
2 winged "Saturn" implants (Cortex-Israel) were placed at the preserved #24/# 25 extraction sites (Fig. 6). A regular Dynamix Cortex implant was inserted at #26 site.

Fig.6 - 2 Winged "Saturn" implants at #24 and #25 sites. Note the Wing penetrating the crest.

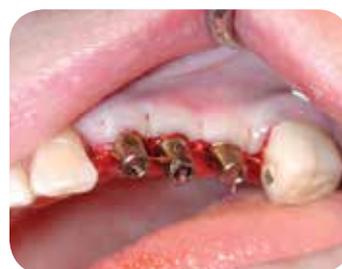
Although the preserved extraction sites were not finally calcified, a 40Ncm resistance torque was achieved (Fig.7).

Fig.7- 40Ncm resistant torque was achieved in spite of the relative soft bone at the preserved sites.
